CONNECTICUT RIVER BASIN
HARRISVILLE, NEW HAMPSHIRE

SEAVER RESERVOIR DAM
NH 00094

PHASE I INSPECTION REPORT
NATIONAL DAM INSPECTION PROGRAM

JULY 1979

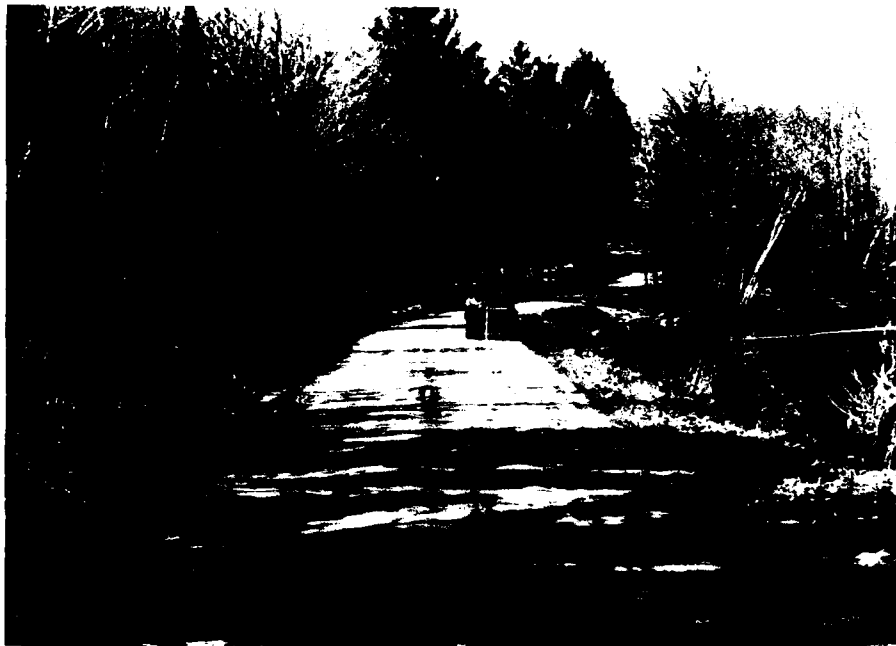
b. Dam. Seaver Reservoir Dam is an earth embankment with a hydraulic height of 28 feet, 325 feet long, and 30 feet wide at the crest. The crest of the dam carries a gravelled roadway. (See Appendix C - Figure 2.) No evidence of erosion of the crest was observed. The upstream face of the dam has a slope of approximately 2H:1V. Brush is growing on the upstream slope above reservoir level and there are a number of tree stumps, up to about 12 inches in diameter, on the upstream slope. (See Appendix C - Figure 3.) Riprap on the upstream slope extends from about 2 feet above reservoir level at the time of the inspection to an unknown elevation below water level. The downstream slope of dam is earthen and has a slope of approximately 1.5H:1V. A heavy growth of trees and some brush were noted on the downstream slope. Trespassing has resulted in significant erosion on the downstream slope in the vicinity of the spillway outlet pipe. Trash has been dumped at several locations on the downstream slope. The downstream toe is retained behind a vertical stone wall about 4 feet high at the discharge end of the spillway pipe. There is a major bulge in this wall and it appears to be on the verge of collapse. (See Appendix C - Figure 4.) Upslope from this wall, and directly above the alignment of the spillway discharge pipe, is a depression about one foot deep and 3 feet in diameter. (See Appendix C - Figure 5.)

April 30, 1979
Figure 2 - Looking northwest across the crest of
the dam embankment.

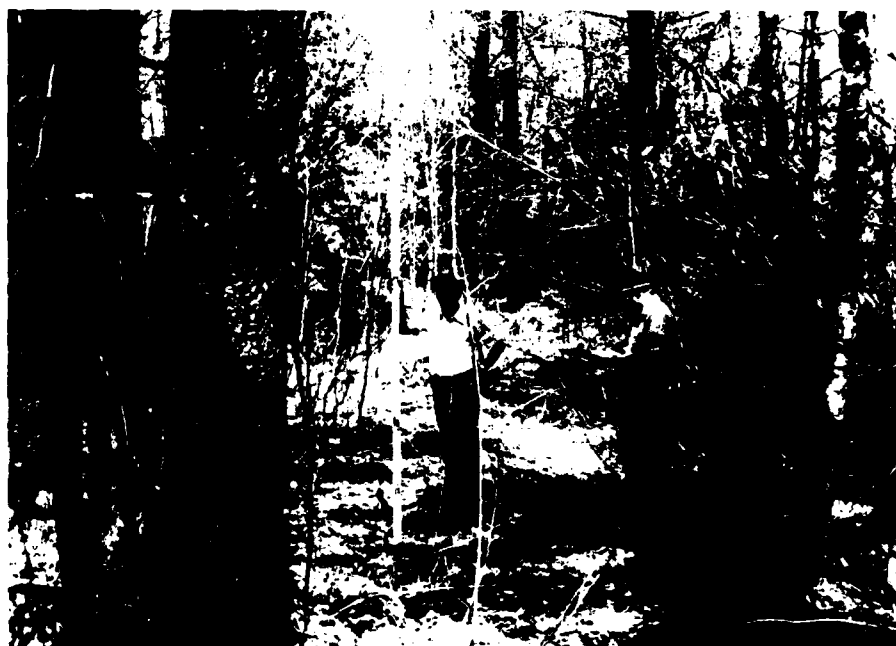
The emergency spillway is in poor condition. It is covered with a heavy growth of trees and brush and could easily be plugged during periods of high flows.

(4) Emergency Spillway. At the southeastern tip of the reservoir there is an emergency spillway. (See Appendix C - Figures 9 and 10.) The spillway itself is broad and flat, and does not have a well-defined channel. It is covered with a heavy growth of trees and brush. A concrete core wall, 10 inches wide, 3 feet deep and projecting about 1½ inches above ground surface, is shown on design drawings but was not observed in the field. This spillway is 120 feet long and 20 feet wide.

April 30, 1979
 Figure 9 - Looking across the emergency spillway
 located at the southeastern point of
 the reservoir.

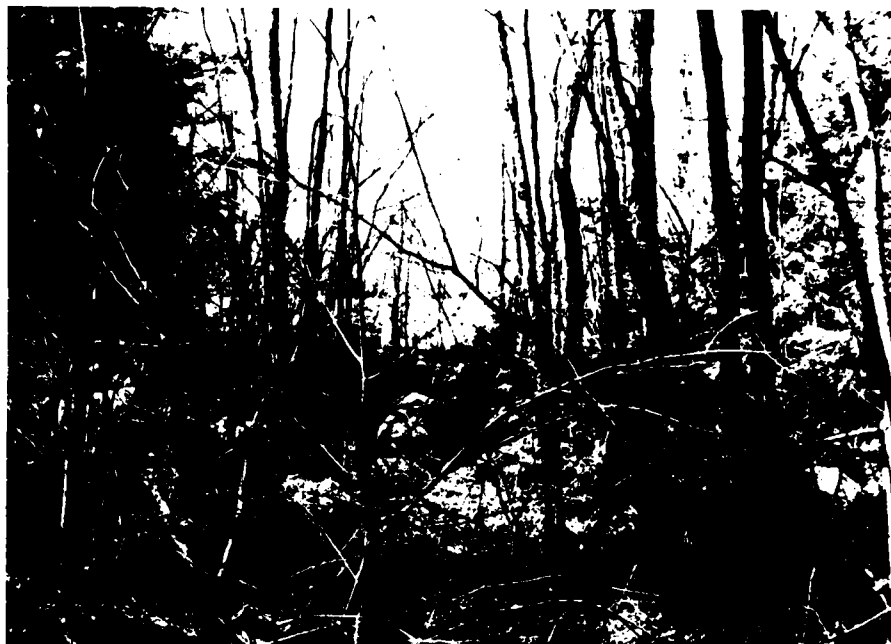
April 30, 1979
Figure 10 - Looking upstream from the emergency
spillway.
